# Thin-Skinned Debris Flows in Cape Breton Highlands National Park, Nova Scotia, Canada

KIMBERLY WAHL,<sup>1</sup> IAN SPOONER,<sup>2†</sup> AND DAVID COLVILLE<sup>3</sup>

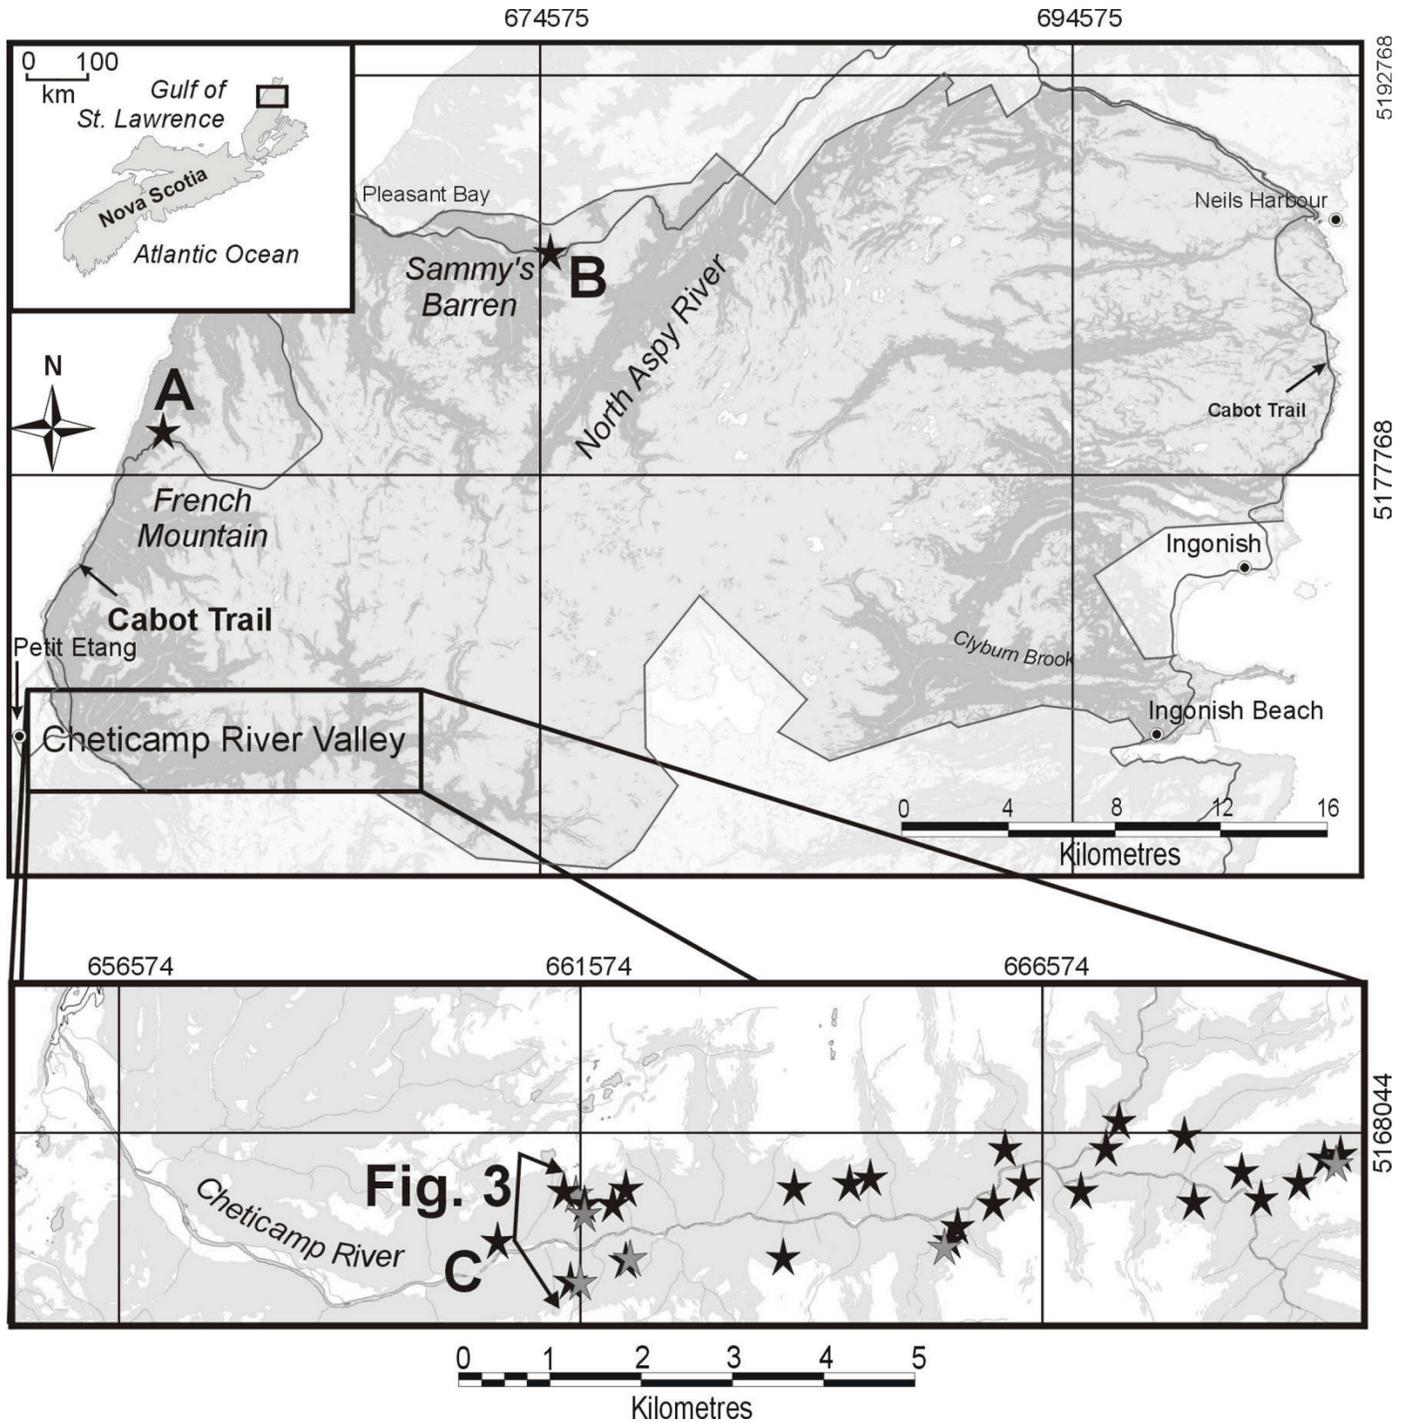
**Fig. 1** Landslide sites investigated within CBHNP and the Chéticamp River Valley area (Sites A, B, C). The Chéticamp River Valley has the greatest concentration of debris flows with over 32 recent and relict landslide scars documented. Not all landslides in CBHNP are shown on this map. Stars (black and grey for visibility) indicate landslide sites in the Chéticamp River Valley identified from 1999 aerial photographs.

CBHNP is dominated by a flat-topped peneplain that comprises 65% of the land area (Wahl 2003) and is deeply incised by a well-developed drainage network (Fig. 1). The western portions of the CBH in particular are characterized by extensive deposits of felsenmeer, grus, and saprolite, which blanket the peneplain, whereas the steep valley walls are mantled by a thin covering of colluvium. It is this colluvium layer, which overlies thin deposits of glacial till or directly overlies bedrock, that is most susceptible to failure within the CBHNP (Finck 1993).

CBHNP (Fig. 1) is situated on the northern peninsula of Cape Breton Island, Nova Scotia, straddling the border

Although examples of slope failure were identified within each river valley, field examination of failure sites was difficult. The dense forest canopy and abundant vegetation in the deeply incised river valleys prevented site investigation of many of the sites observed in the imagery. Detailed field investigations were carried out at French Mountain (Site A, Fig. 1) on the east side of the CBHNP and Sammys Barren (Site B, Fig. 1) in the north-central region of CBHNP. Thirty two debris flow scars were identified in the Chéticamp River Valley; one site (Site C, Fig. 1) was chosen for detailed examination due to ease of access.

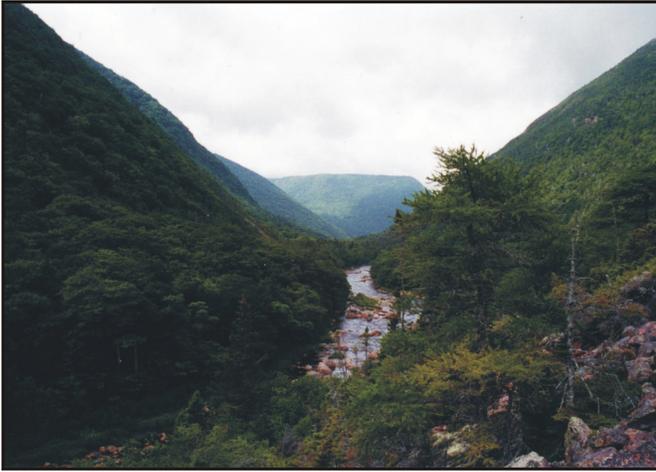
**Fig. 2** Photograph of the Chéticamp River Valley (looking west), showing the V-shaped valley profile and consistent slope angle that is common in the Cape Breton Highlands. Note the active talus slope on right (north) side of the photograph. Relief is approximately 270 m.

The CBH form part of a regionally extensive erosional surface, or peneplain, that dips gently to the southeast and is bounded by steep and rugged walls and rise to elevations of over 530 m (Finck 1993; Grant 1994). This upland peneplain has a consistently smooth surface, with gentle gradients, smoothly rounded interfluvies, very little exposed bedrock, and few of the undulations typically associated with glacially modified terrain (Grant 1994). Radiating outward from the centre of the domed peneplain is a well-developed network of deeply-incised, V-shaped valleys marking extensive fluvial erosion (Fig. 2).

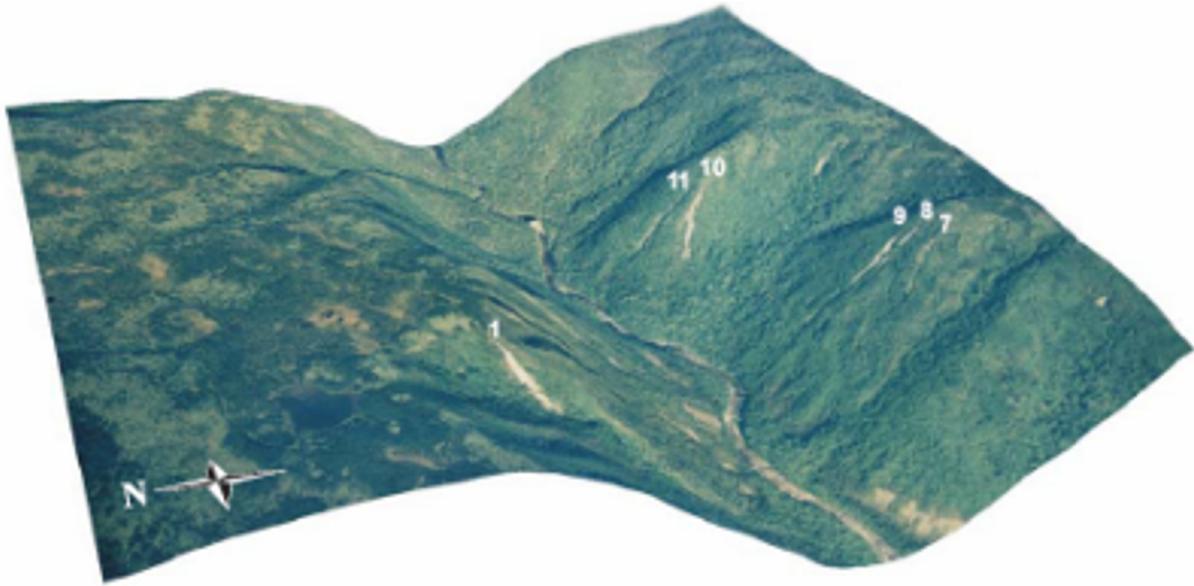
**Fig. 3** 3D perspective of aerial photograph 99311-67, looking east. This photograph was draped over a 5 m DEM to generate a three-dimensional perspective of the V-shaped valley form typical in Cape Breton Highlands National Park. Failure occurred on open slopes rarely associated with large-scale gullies or surface depressions. Relief in this image is approximately 400 m (Note: no vertical exaggeration). Photo Source: Service Nova Scotia and Municipal Relations, Nova Scotia Geomatics Centre, 160 Willow Street, Amherst, NS.

The debris flow scars identified in CBHNP are typically long, narrow, and relatively straight, initiating near the top of the valley wall where the slope gradient is generally the steepest (Fig. 3). Head scarps commonly occur just below the peneplain edge at elevations ranging from 260 m to 401 m, with an average of 340 m. The slopes where failures occur range from 27° to 48°, with an average gradient of 39°. They tend to be slopes where there is little to no association with large-scale surface depressions or gullies. Although these flow scars were observed as spanning the entire length of the slope to the valley floor, they can be shorter (< 150 m in length). The debris flow scars are relatively narrow (5 m to 20 m) and shallow, removing 0.5 m to 1.5 m of surface sediment; we call these failures thin-skinned debris flow. The remnant debris apron is primarily gravel to boulder sized, with the fine fraction most likely removed by consequent rainfall and snowmelt. This debris is consistently angular, unsorted and exhibits down-slope heterogeneity of clast size and composition. The presence of inverted trees of varying size, shattered rock, and scouring to bedrock indicate that failure is rapid and turbulent, and falls broadly within the classification scheme of debris flow (Varnes 1978).

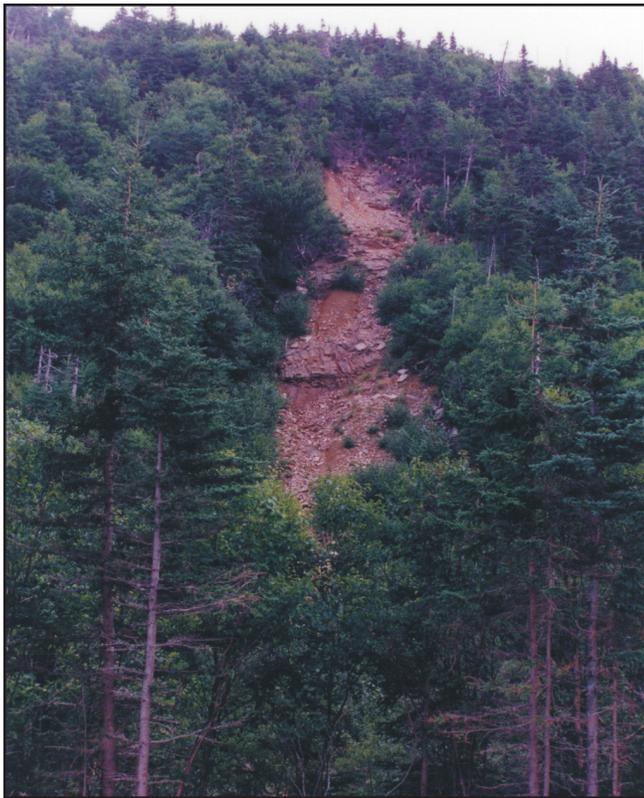
**Fig. 4** Debris flow on a south-facing slope of French Mountain (see Fig. 1, Site A). This debris flow is long and narrow, was initiated just below the penplain-valley wall intersection, and ran the entire length of the slope.

Site A (Figures 1, 4, 5, 6, 7) is located on the south-facing (217°) slope of Ruis Sauteu Brook, on the north side of French Mountain (661165E, 5179120N). This site, also accessible directly off the Cabot Trail, is a recent debris flow similar to other flows within the study area. Failure occurred at 374 m ASL on a 33° slope of granitoid gneiss (Barr *et al.* 1992). This flow, which extends the entire length of the slope, is long (125 m) and narrow (10 m wide at the initiation zone), and denuded

approximately 1 m of material from the initiation zone (Fig. 4). Although the centre of the flow track appears to have stabilized, as evident from the re-growth of white birch (*Betula papyrifera*), the sides of the track have remained unstable or recently been remobilized on a small scale. A mass of debris including boulders, rock fragments, fine- to coarse-grained sediment, inverted trees, and other vegetation had accumulated at the base of the slope and altered the natural hydraulics of the brook (Fig. 5). This change is evident from an accumulation of fine- to medium-grained sediment upstream of the obstruction not seen elsewhere in the brook. Examination of the initiation zone at this site revealed a thin layer of over-compacted, matrix-supported, non-porous glacial sediment smeared as a thin veneer, perhaps only 10–20 cm thick, underlying the colluvium (Fig. 6). The contact between the impermeable lodgement till and the highly permeable surface colluvium could act as a barrier to water infiltration and thus provide a conduit for groundwater transport with very low perceived friction. This conduit would force groundwater flow along the surface of the till barrier, thereby decreasing shear strength and creating a favourable location for the initiation of slip.

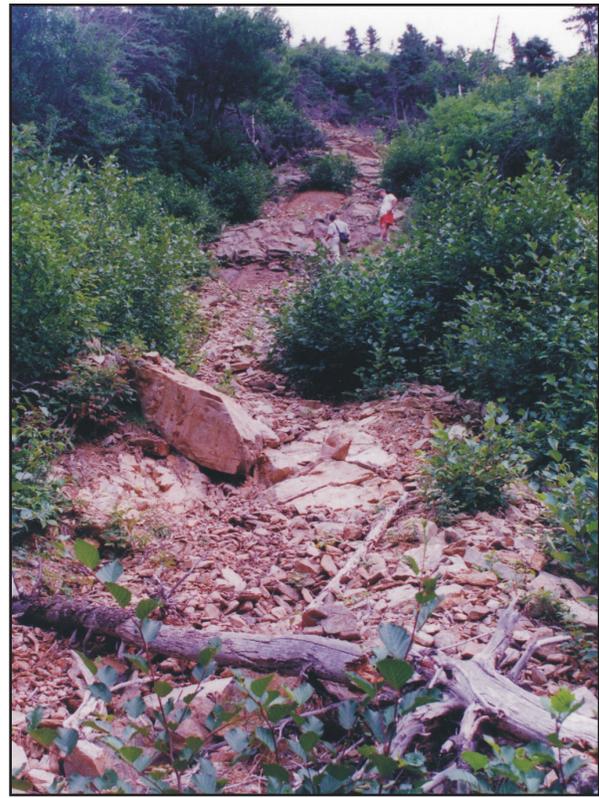
**Fig. 5** French Mountain site (Site A; Fig. 1) looking up from the debris apron at the base of the landslide. The fines have been winnowed from the debris flow very quickly after the initial event and inverted, partially buried trees are found in the debris pile.

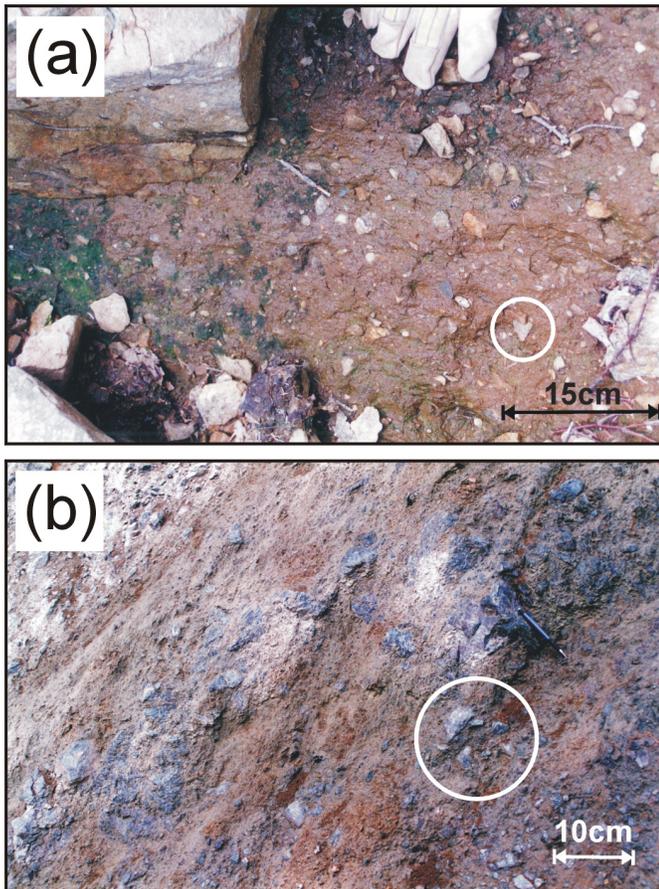
**Fig. 6** Diamicton interpreted to be lodgement till observed in initiation zone at the French Mountain site (Site A; Fig. 1). Circles on images (a) and (b) identify examples of the angular to sub-angular, matrix-supported clasts common in this till.

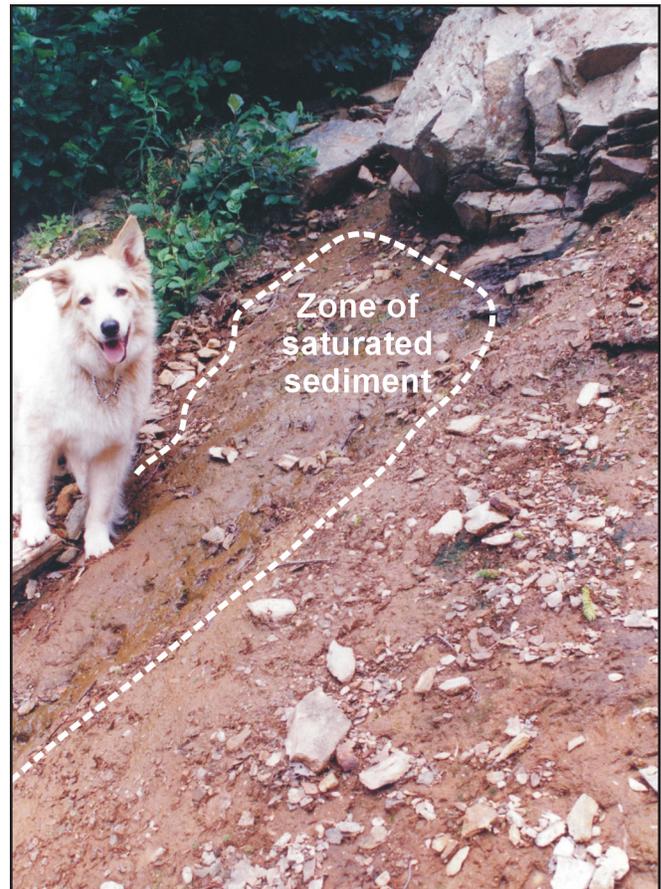
**Fig. 7** French Mountain (Site A; Fig. 1). Dashed area denotes ground saturated by groundwater seeping from bedrock fracture and cleavage planes five days after the last rainfall event.

site was an outcrop of highly cleaved semi-pelitic gneiss. Although the summer of 2001 was a relatively hot and dry period (G. Morin, Environment Canada, personal communication, 2002), a steady flow of groundwater seeped from cleavage and fracture planes of exposed bedrock onto the adjacent layer of lodgement till (Fig. 7).

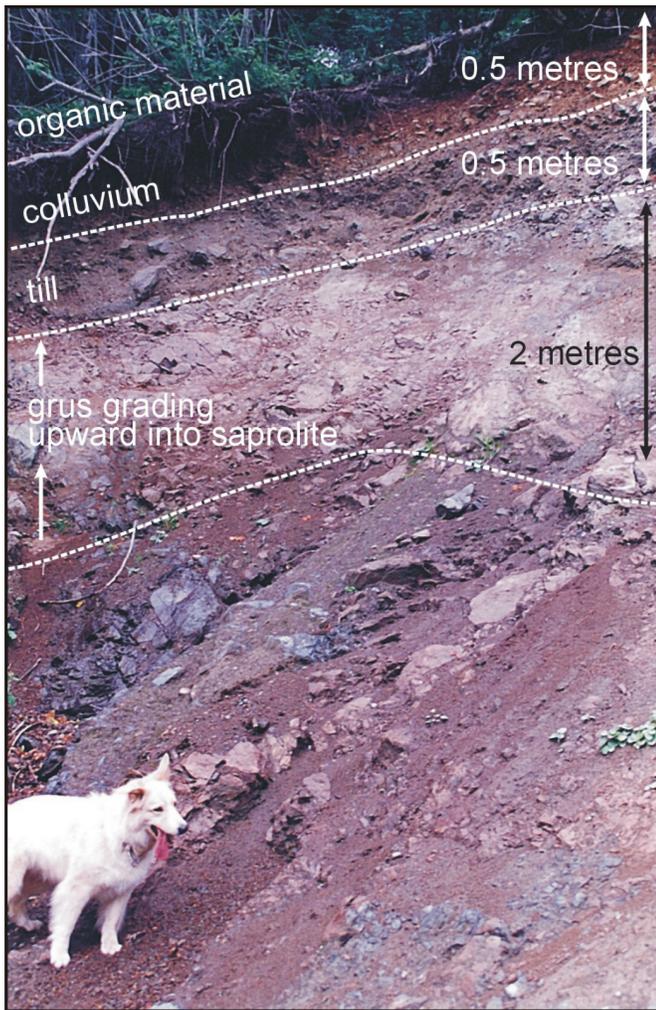
**Fig. 8** Stratigraphy at head scarp of Sammys Barren site (Site B; Fig. 1). Weathered bedrock with grus grades upward into saprolite and is overlain by till and colluvium. Small rivulets are evident on the left side of the image due to seepage from cleavage planes and cracks in the weathered bedrock.

In the initiation zone at Site B, complex stratigraphy was exposed (Fig. 8). Several hydrostratigraphic units appear within the overlying soil mantle, and from the surface to the underlying bedrock are: (1) a 15 cm humic layer, (2) a 50 cm-thick unsorted mixture of loose, heterogeneous, fine to coarse-grained colluvium and organic material supported primarily by angular to subangular clasts averaging 5–15 cm in diameter; (3) a 50 cm-thick unsorted mixture of fine- to medium-grained colluvium with a more sandy consistency and fewer angular to sub-angular clasts than (2), up to 10 cm in diameter; and (4) a highly compacted fine to very fine grained 0.5 m thick diamicton layer with small (< 5 cm in diameter) subangular clasts. The difference in permeability between the colluvium and till was apparent in the exposed headscarp. Here, water was observed to penetrating the porous colluvium; however, the

contact with the till unit appeared to act as a plane for concentrated groundwater flow. Environment Canada climate records indicate a total of 28.4 mm of rain in the month leading up to field investigations, with no rain falling in the 5 days prior to site investigations (G. Morin, Environment Canada, personal communication, 2002). Despite a lack of rainfall during the field investigation, water seeped from this contact on the face of the headscarp (Fig. 8).

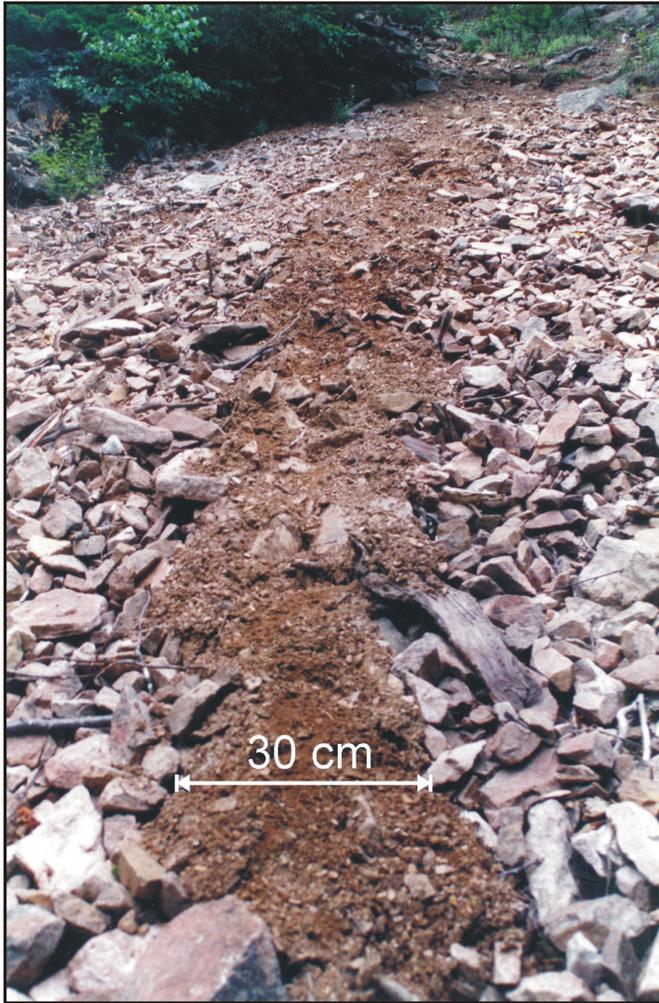
**Fig. 9** Remobilization of fine- to medium-grained material at Site C, Chéticamp River Valley (Fig. 1). This photograph shows the toe of a debris flow from which all fine-grained sediment has been winnowed away by rainfall and snowmelt. The central area of finer grained material represents recently reactivated, newly colluviated sediment transported down slope by surface water runoff.

A recent debris flow scar was observed at Site C (Fig. 1) that was representative of other debris flows in the CBHNP in its long (85 m) and narrow (15 m) form. Approximately 1900 m<sup>3</sup> of colluviated sediment was removed from this site. The debris apron was very coarse as the fine fraction had been winnowed away by rainfall and snowmelt. Despite the re-growth of white birch (*Betula papyrifera*) in the centre of the track, this site appeared to have been reactivated after initial failure, as indicated by the remobilization of sediment in small water-fed rivulets (Fig. 9).
